AFWAL-TR-79-3095
VOLUME II

ADVANCED RESIDUAL STRENGTH DEGRADATION RATE
MODELING FOR ADVANCED COMPOSITE STRUCTURES
VOLUME II - TASKS II AND III

Lockheed-California Company
Burbank, California

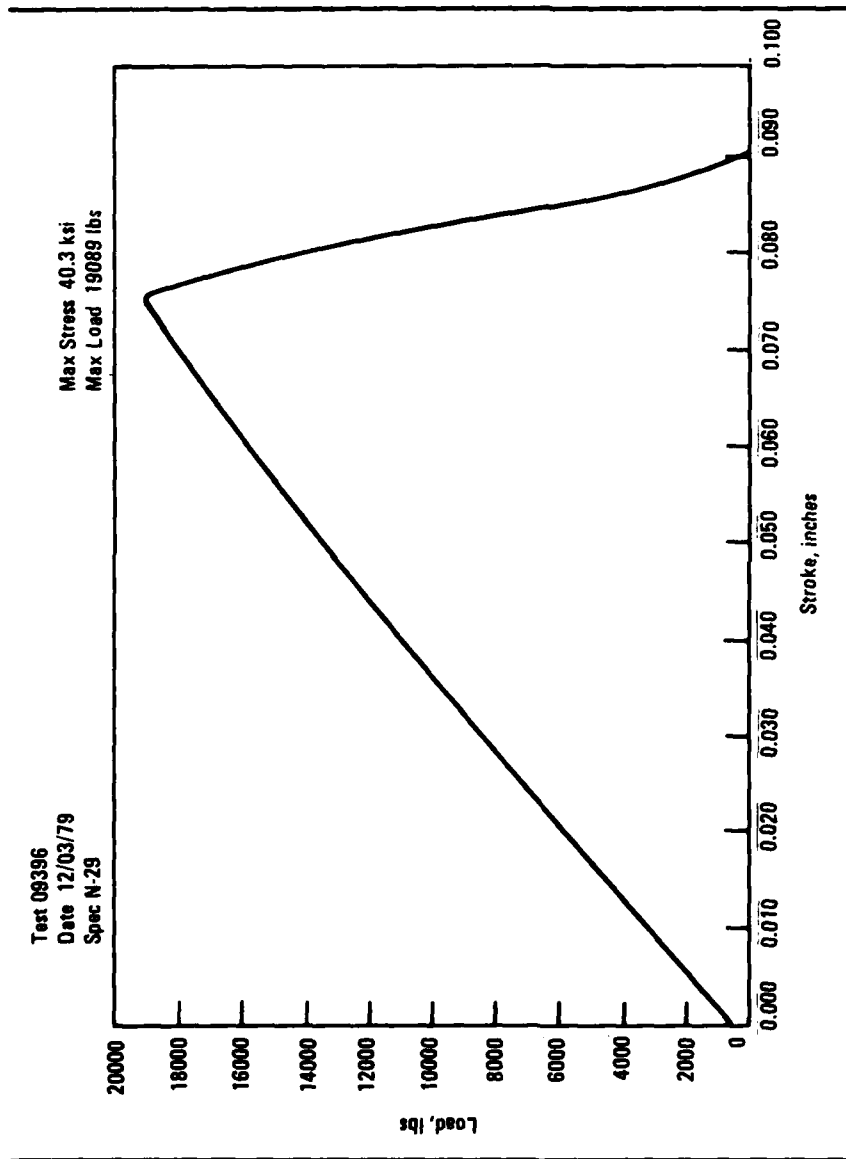
Figure 28: Typical Load vs. Deflection Curve for High Strain Rate Tests of 32-Ply Laminate (Spec. NC-29)

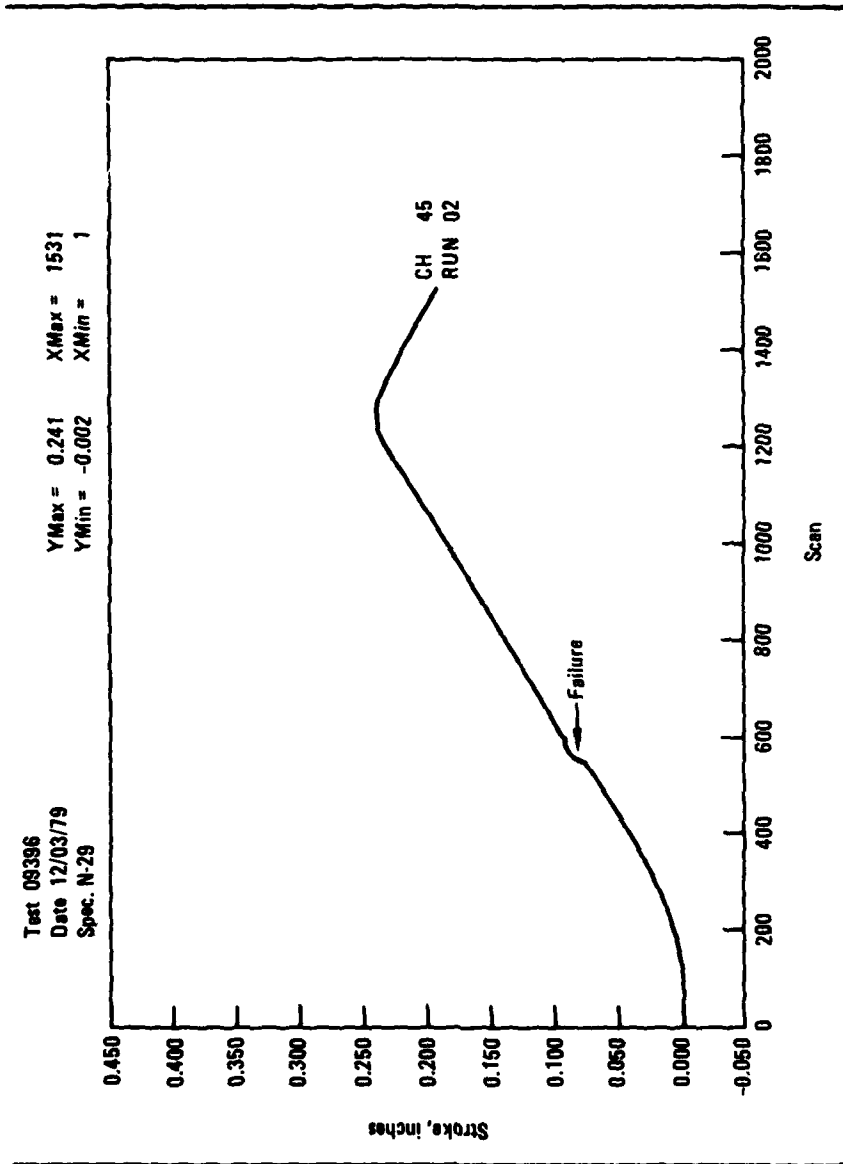
Figure 29: Typical Deflection vs. Number of Scans Curve for High Strain Rate Tests of 32-Ply Laminate (Spec. NC-29)

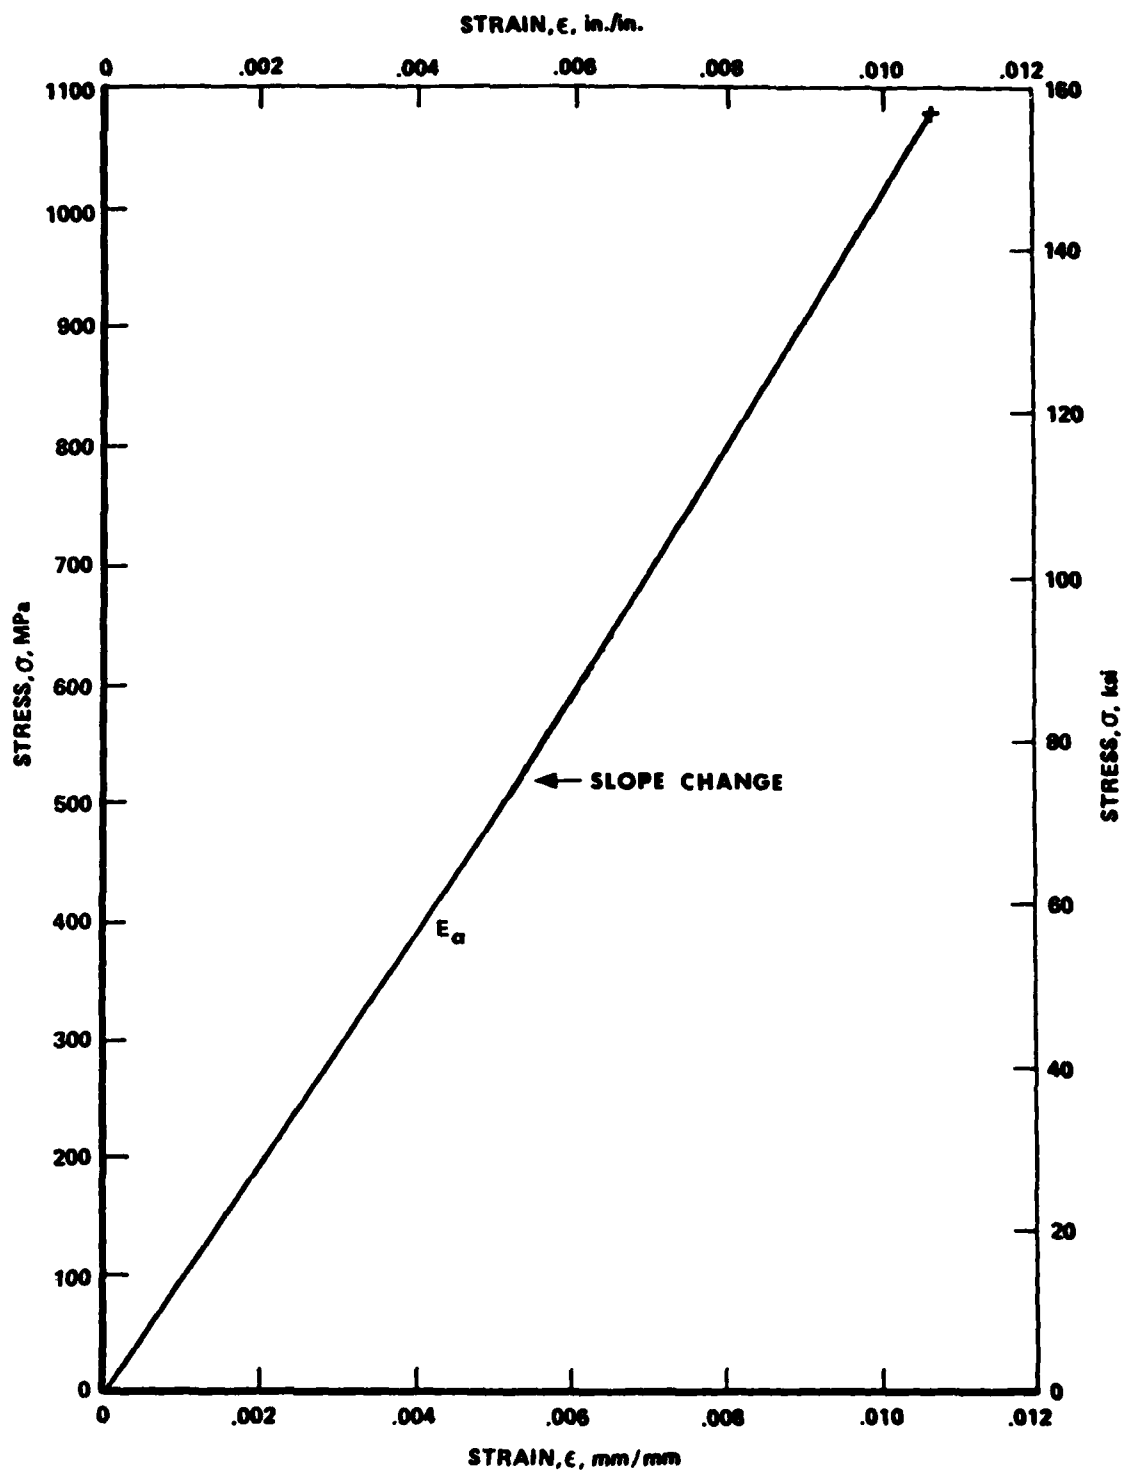
Figure 32: Typical Stress Strain Curve Measured for the 24-Ply 67% 0° Laminate

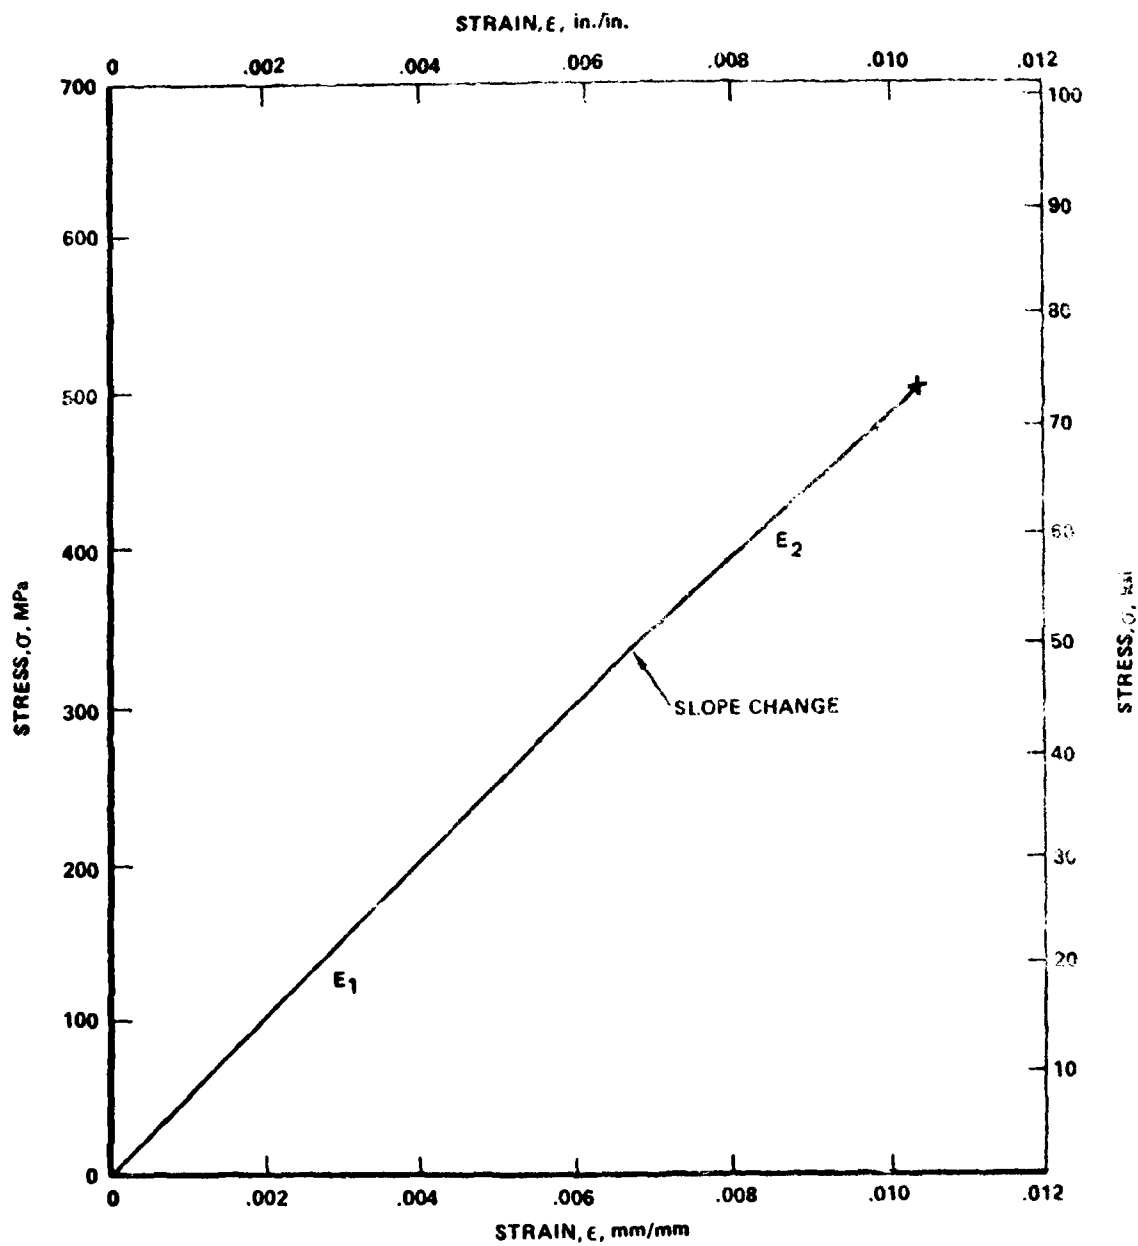
Figure 33: Typical Stress Strain Curve Measured for the 32 Ply Quasi-Isotropic Laminate

The 32-ply laminates exhibited stress-strain curves having a double slope as shown in Figure 33 which was also observed for the Task I material and is typical of this quasi-isotropic lay-up. Stress and strain corresponding to the intersection of the two slopes were determined and are reported in Appendix C of Volume III as slope deviation stress and strain. Results for all three tasks were within a range of approximately $\pm 10\%$ which is typical for data sets involving several processing runs. Very little difference existed between the average fiber volumes for the 32-ply panels of Tasks I, II and III which were 64.96%, 64.84% and 64.47% respectively. Slightly less scatter in fiber volume was apparent in the 32-ply Task II panels which exhibited 0.83% range compared to the 1.9% range for the Task

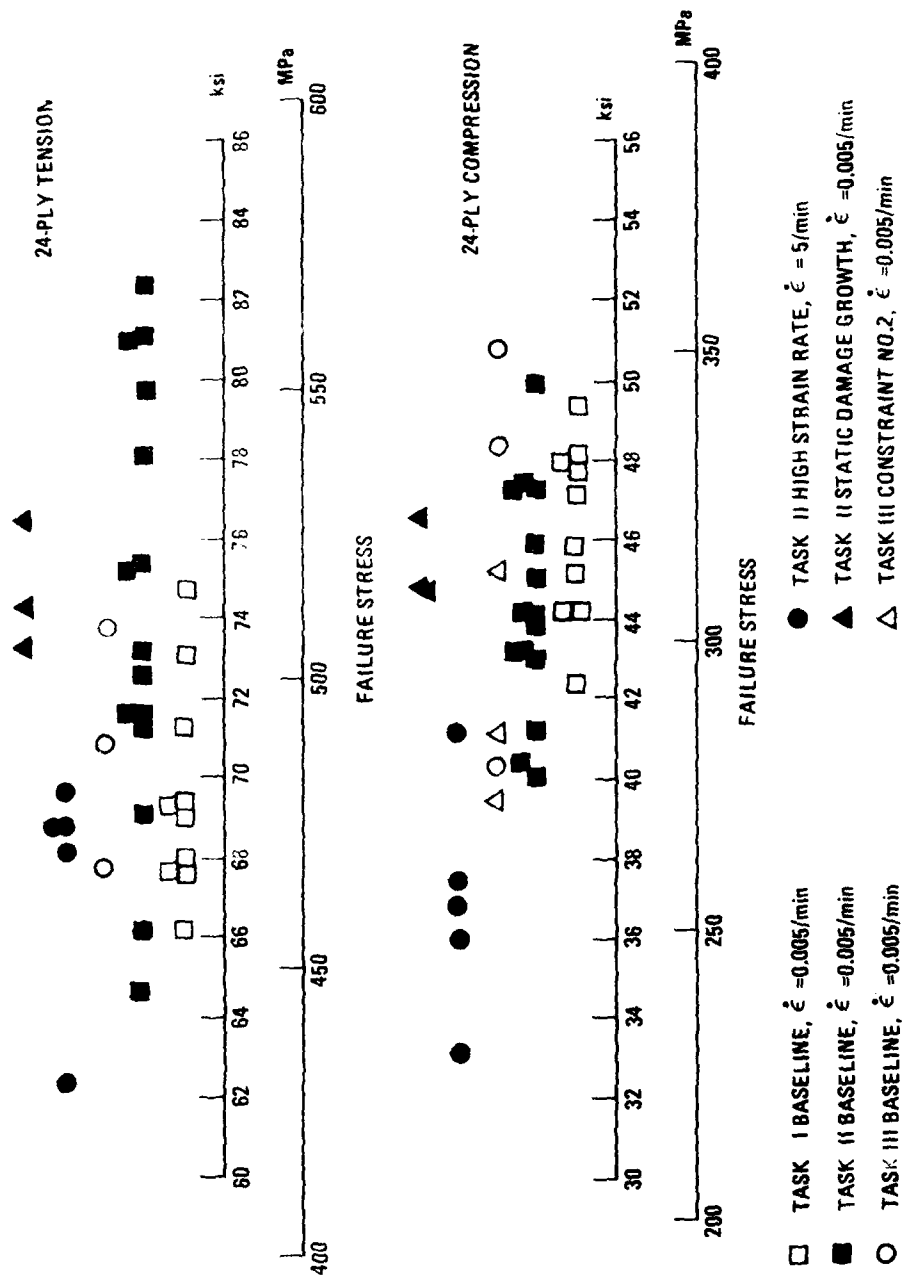
Figure 35: Effect of Loading Rate and Pre-Loading on the Static Strength of 24-ply Laminate Specimens Containing a Damaged Hole

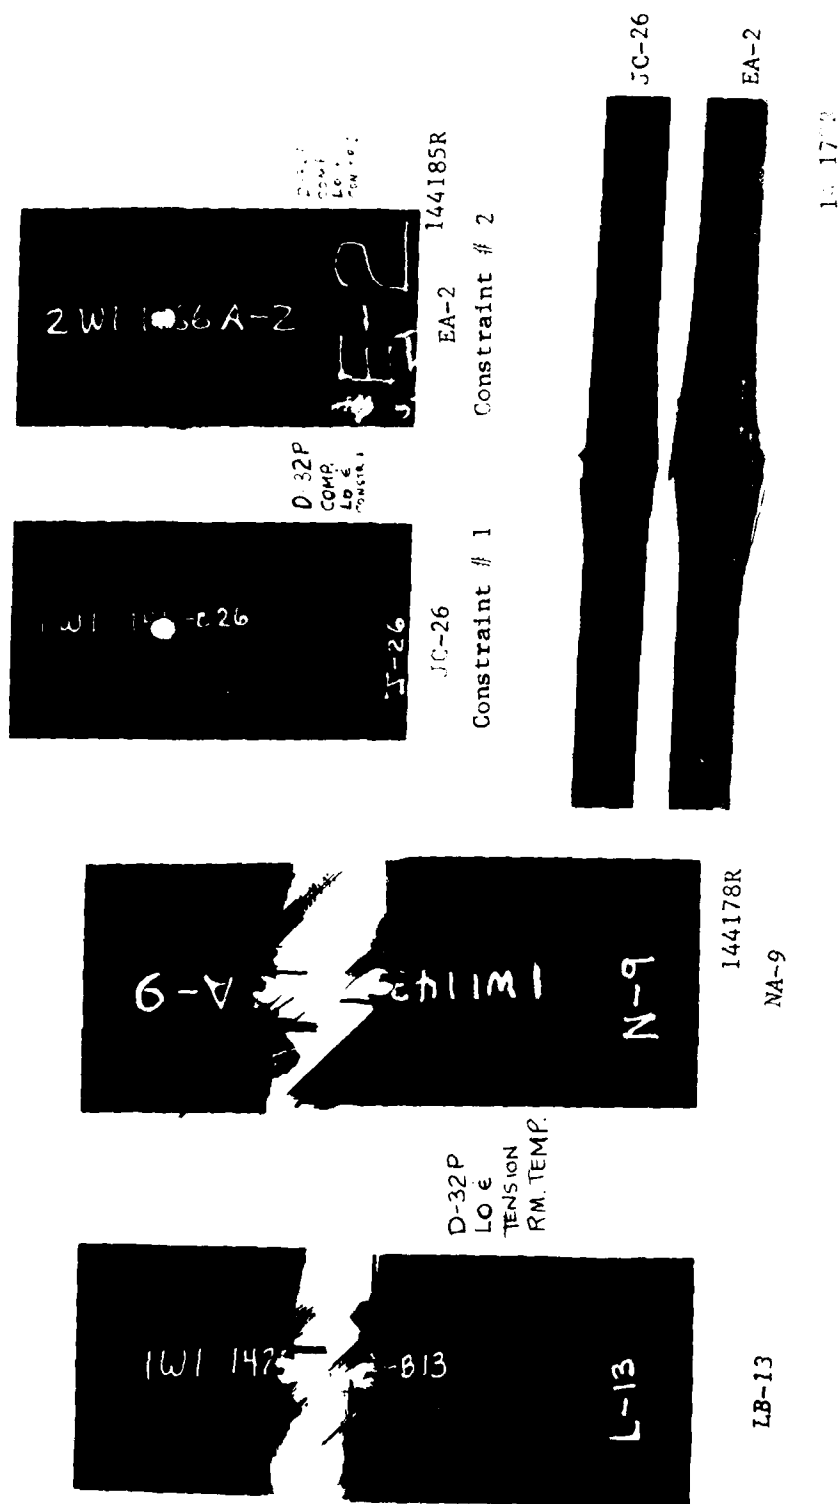
Figure 41: Fracture Features Typical of High and Low Strain Rate Tests for Damaged 32-ply Specimens

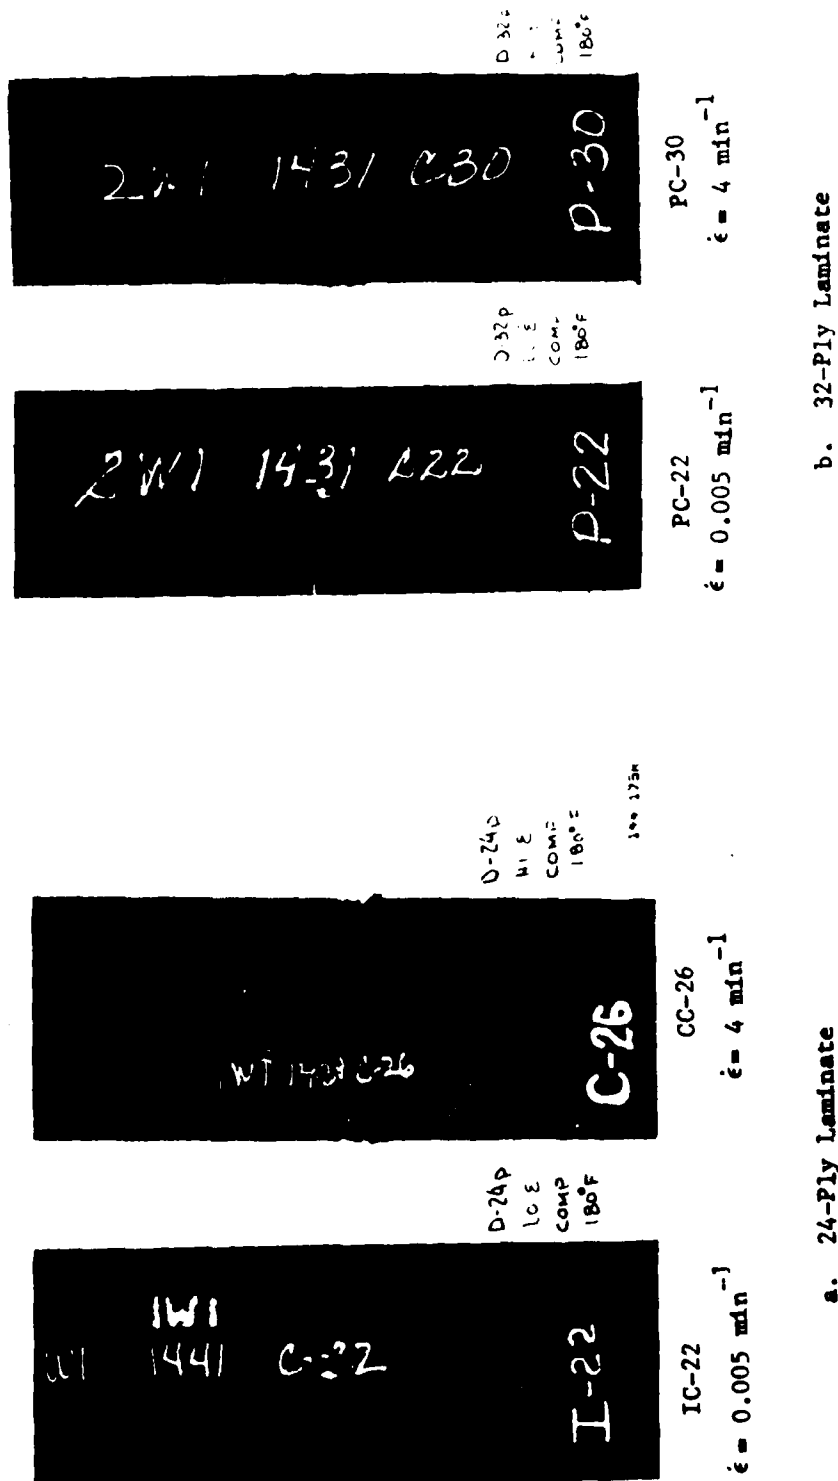
Figure 42: Typical Fractures of Damaged Laminates Tested in Compression at 180°F (82°C)

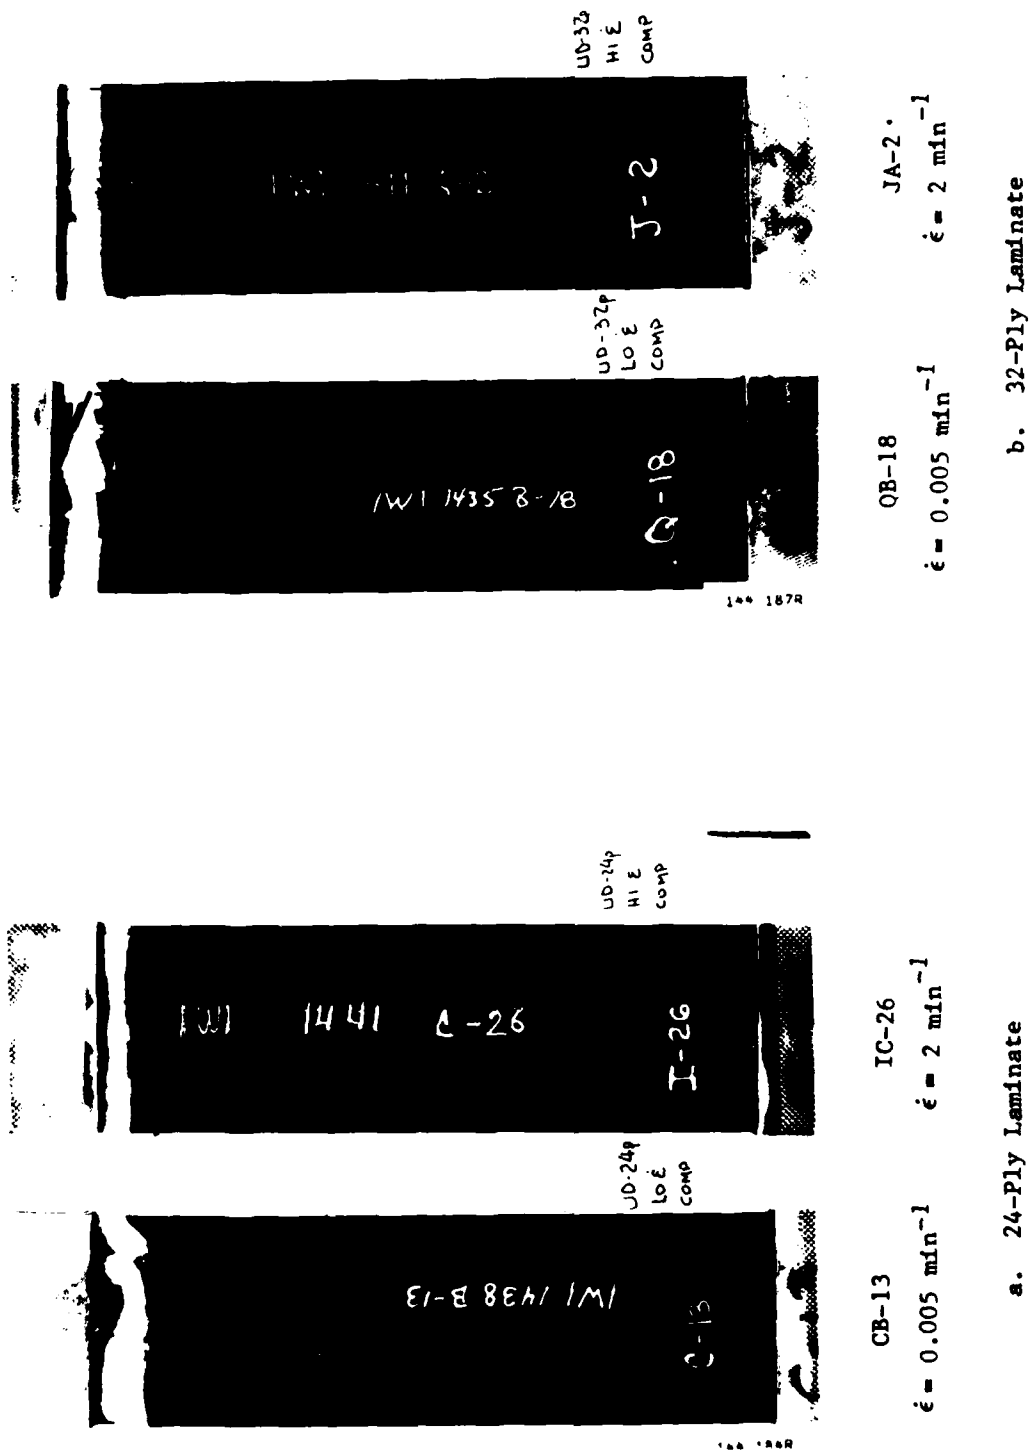
Figure 49: Typical Fractures of Undamaged Specimens Tested in Compression at Room Temperature

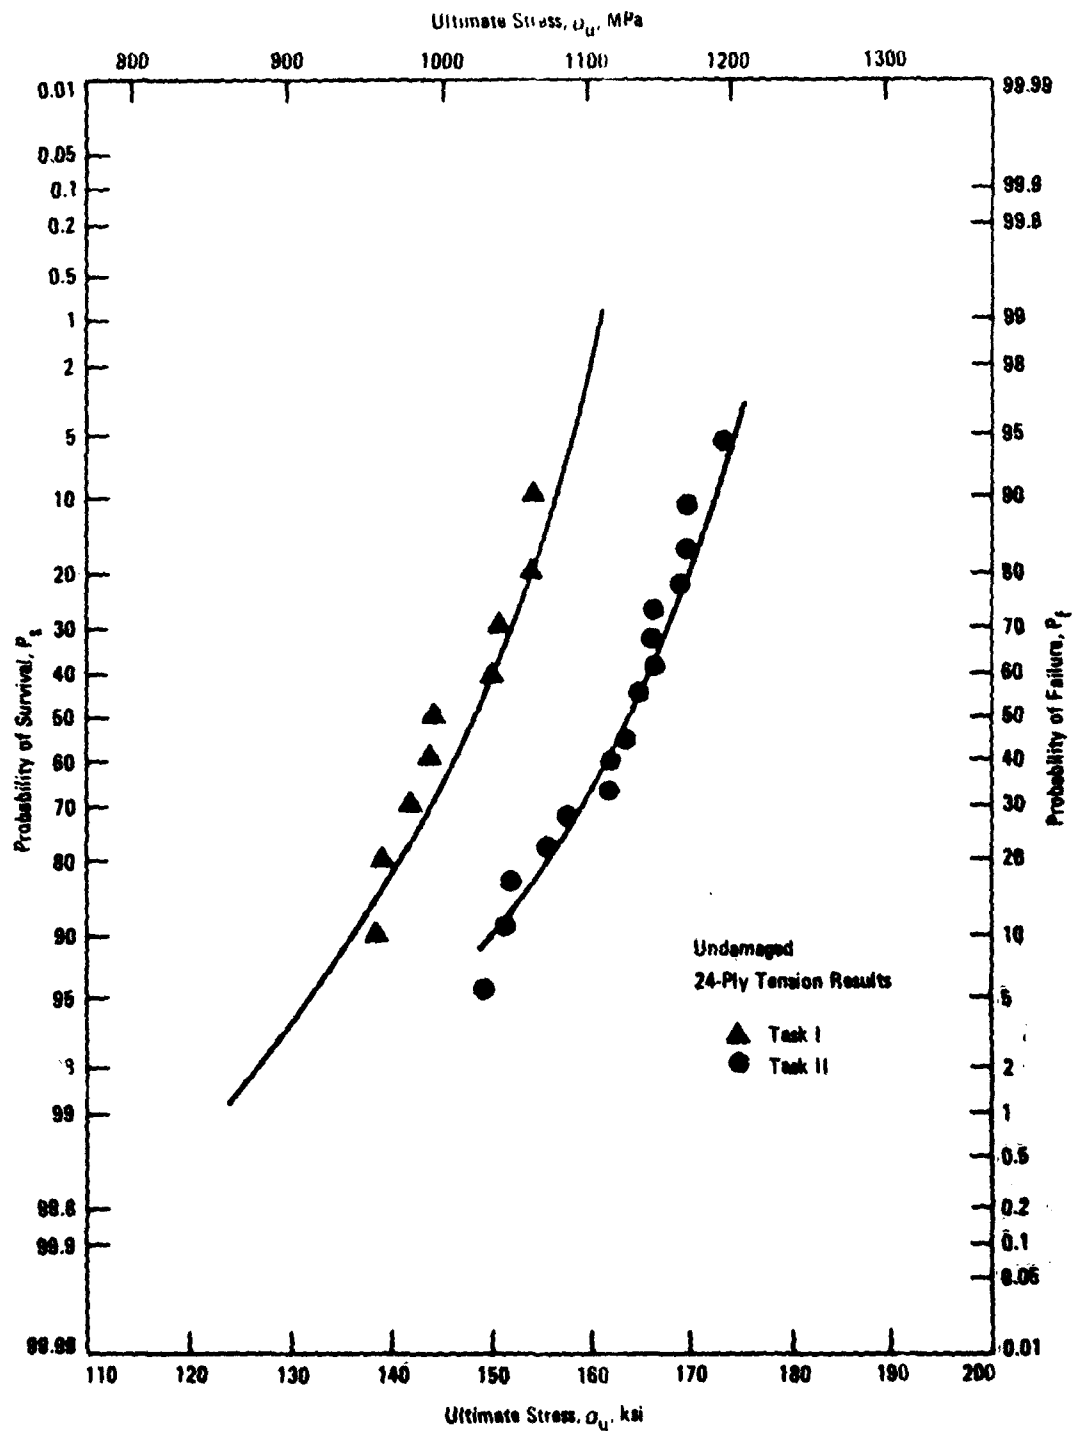
Figure 50 : Comparison of Two Parameter Weibull Curve Fit for Undamaged Task I and II 24-Ply Tension Data

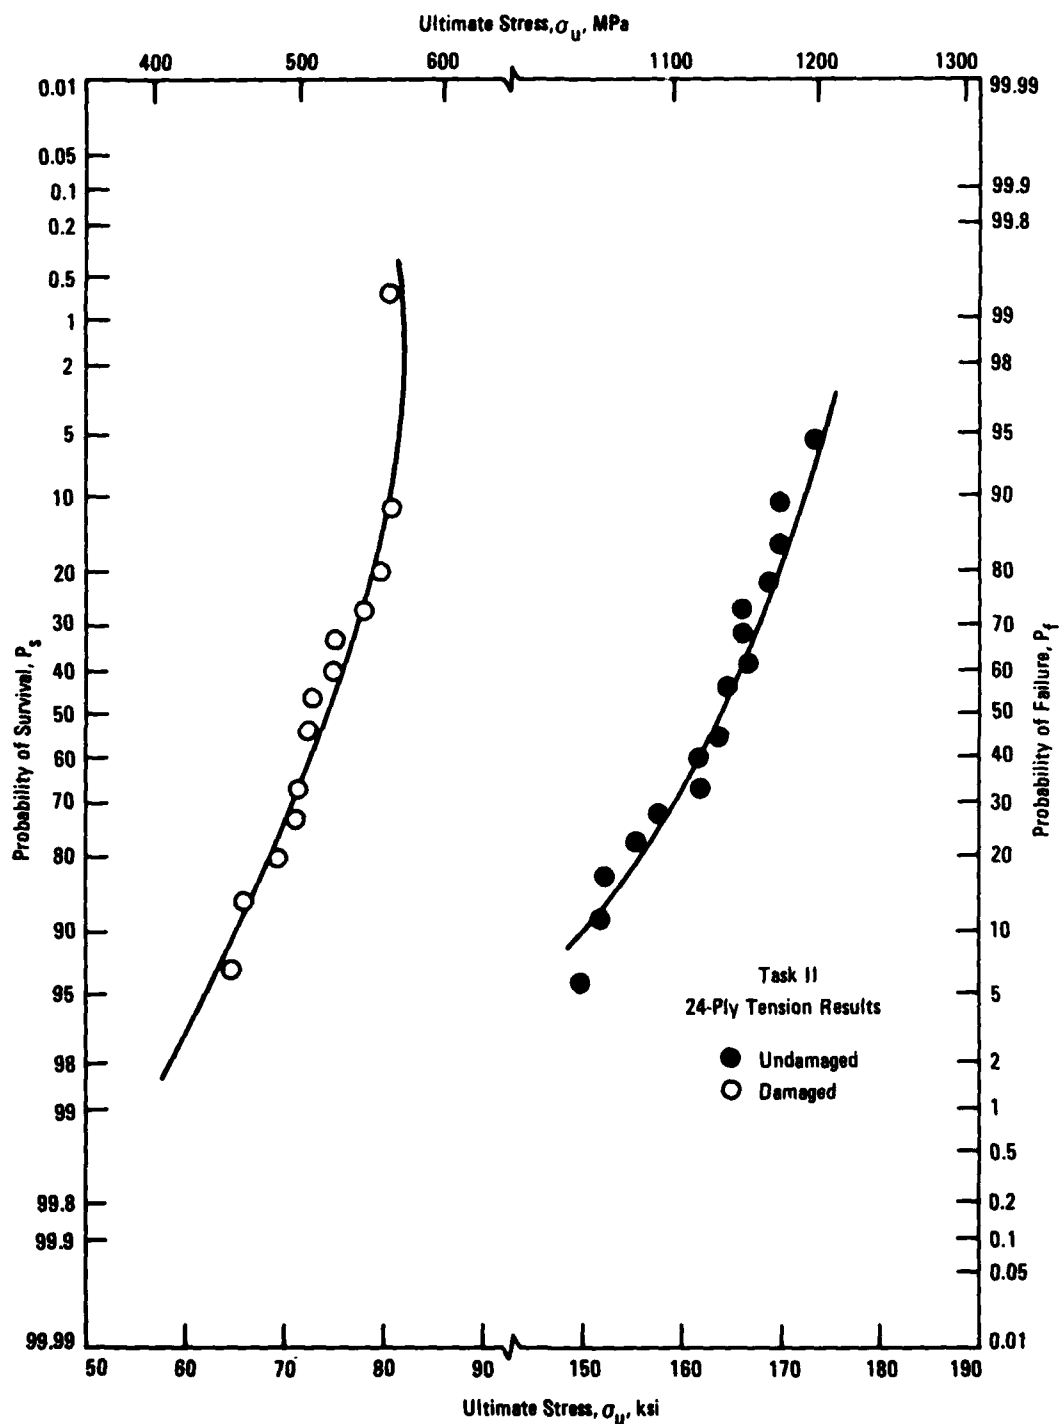
Figure 51: Comparison of Two Parameter Weibull Curve Fit for Undamaged and Damaged Task II 24-Ply Tension Data

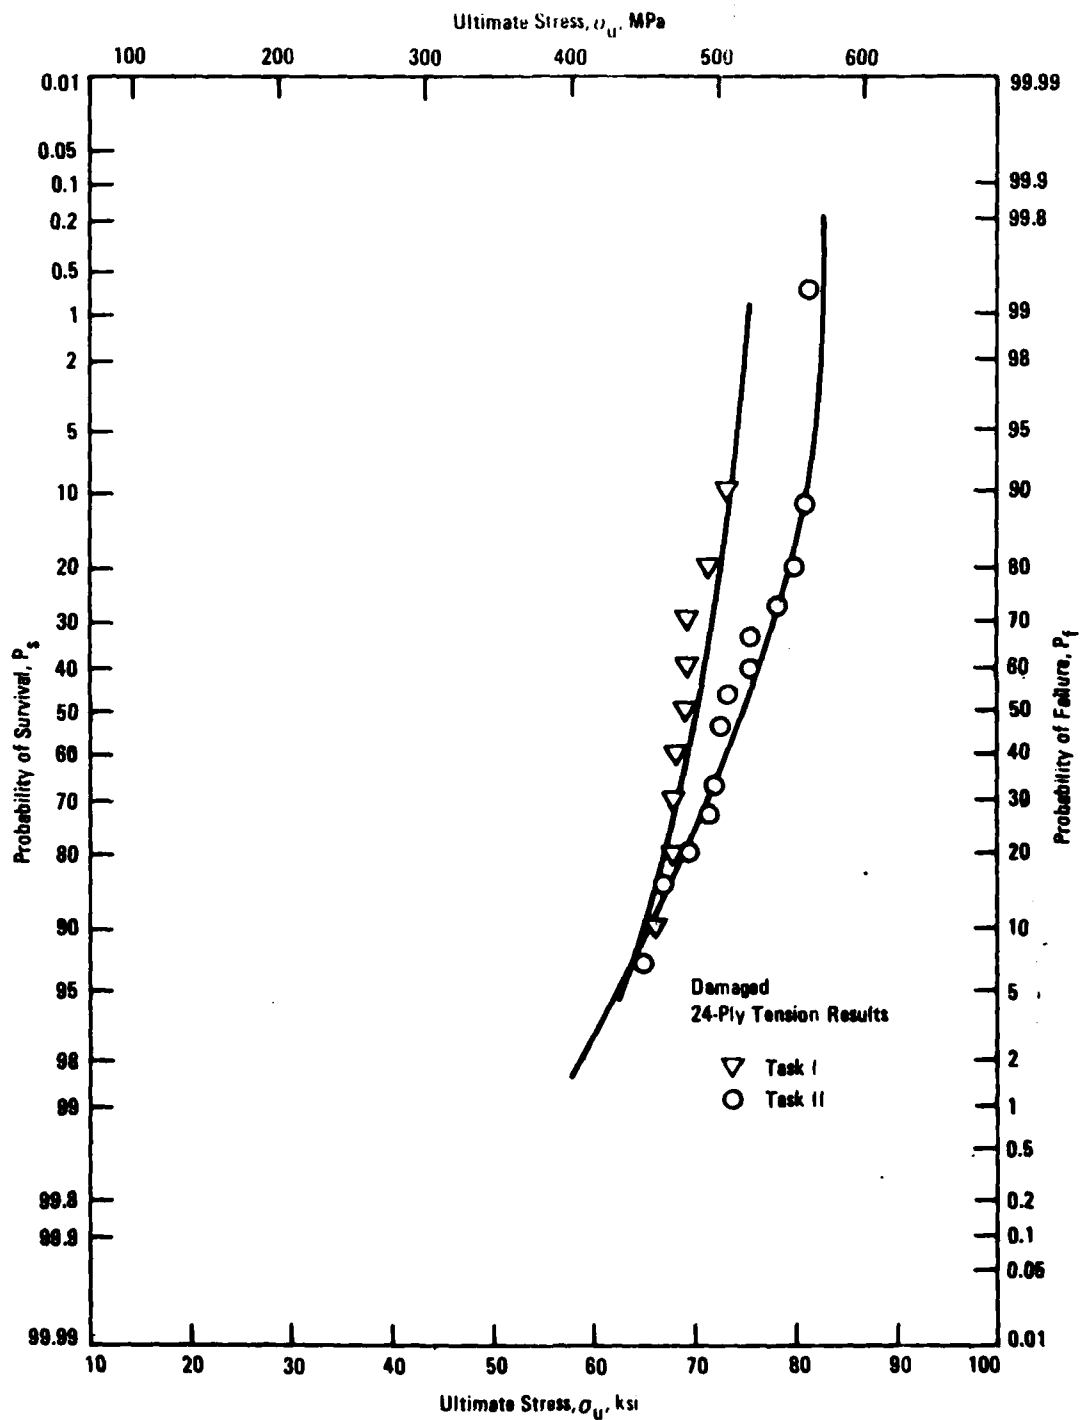
Figure 52: Comparison of Two Parameter Weibull Curve Fit for Damaged Task I and II 24-Ply Tension Data

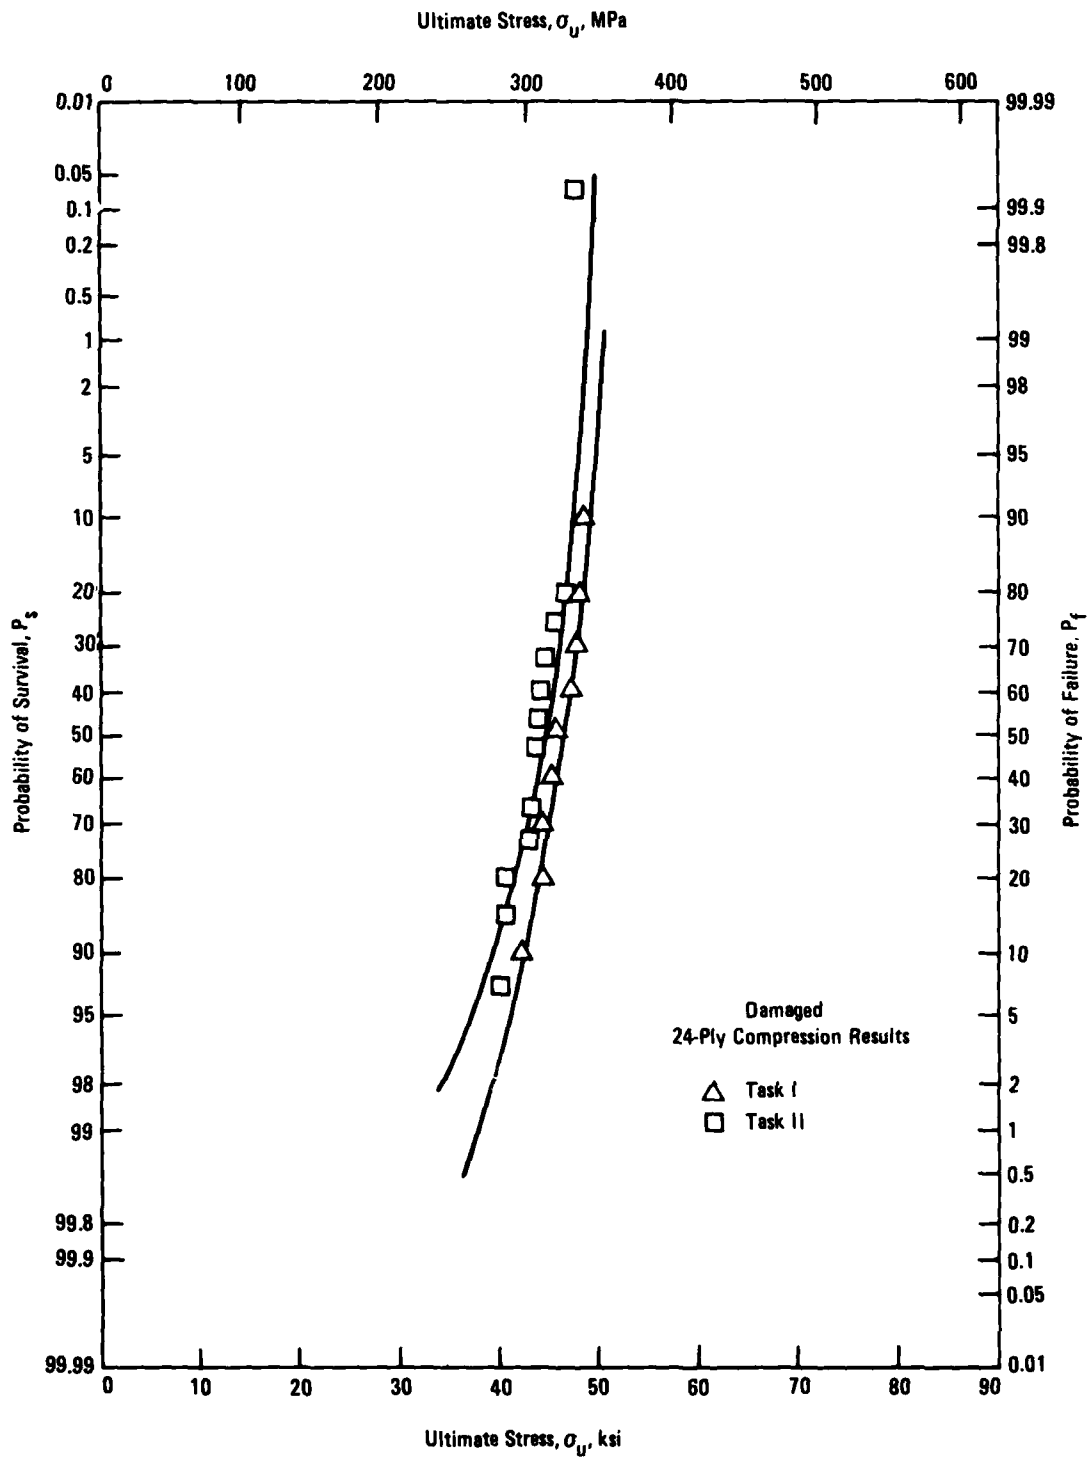
Figure 53: Comparison of Two Parameter Weibull Curve Fit for Damaged Task I and II 24-Ply Compression Data

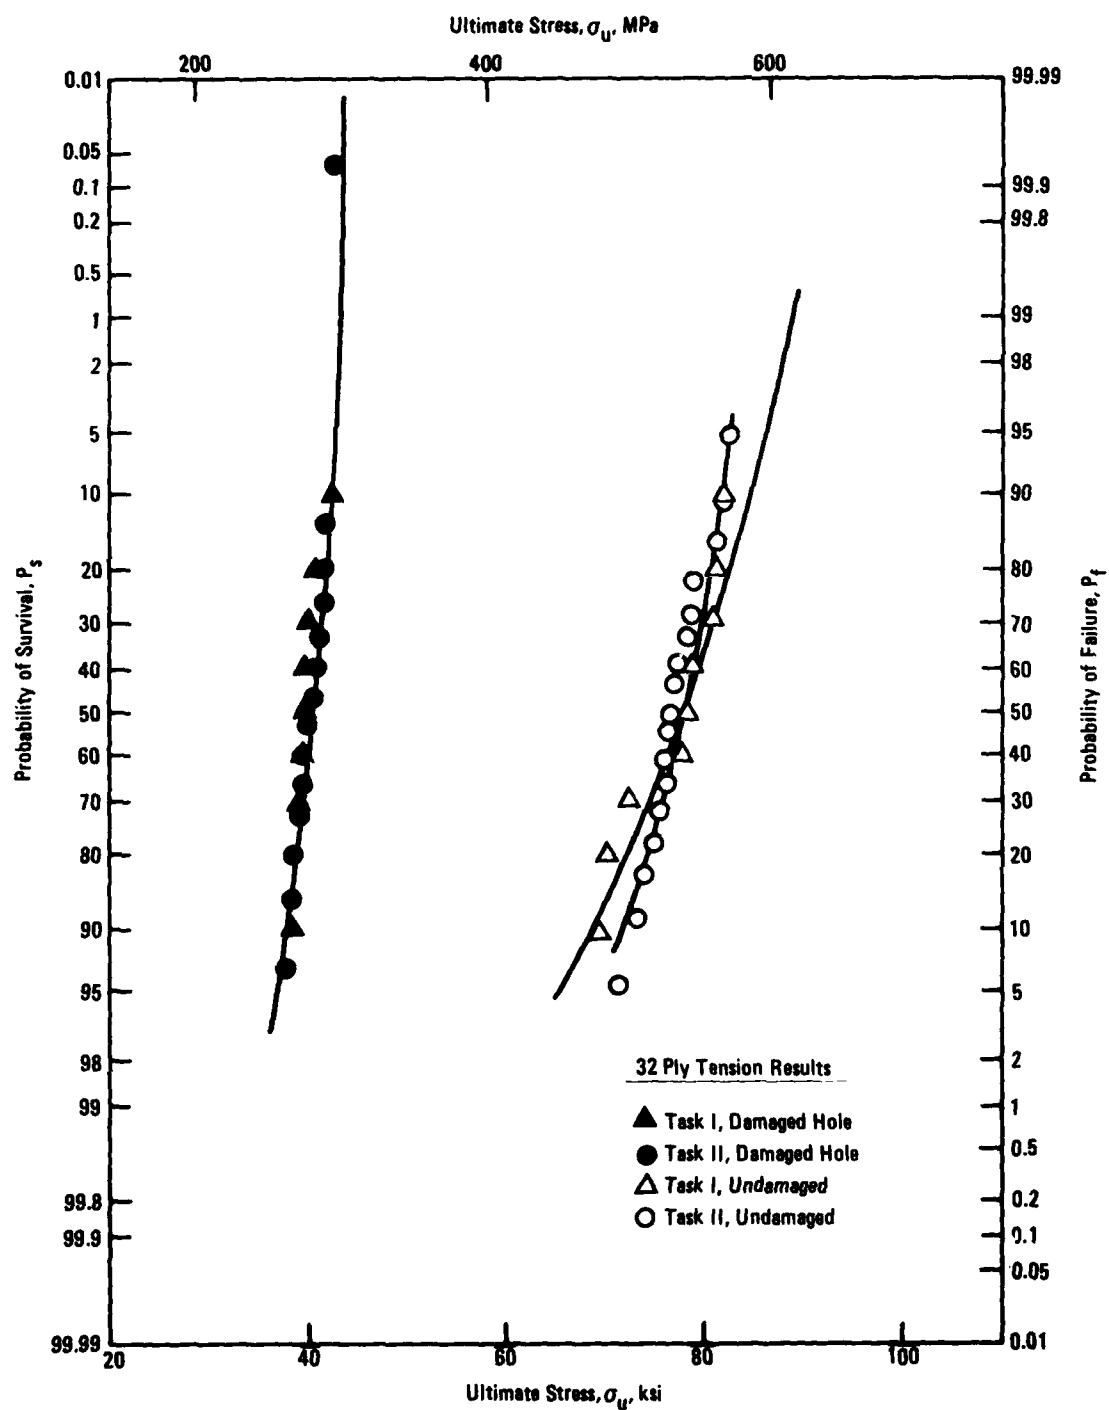
Figure 54: Comparison of Two Parameter Weibull Curve Fit for Task I and Task II 32-Ply Tension Data

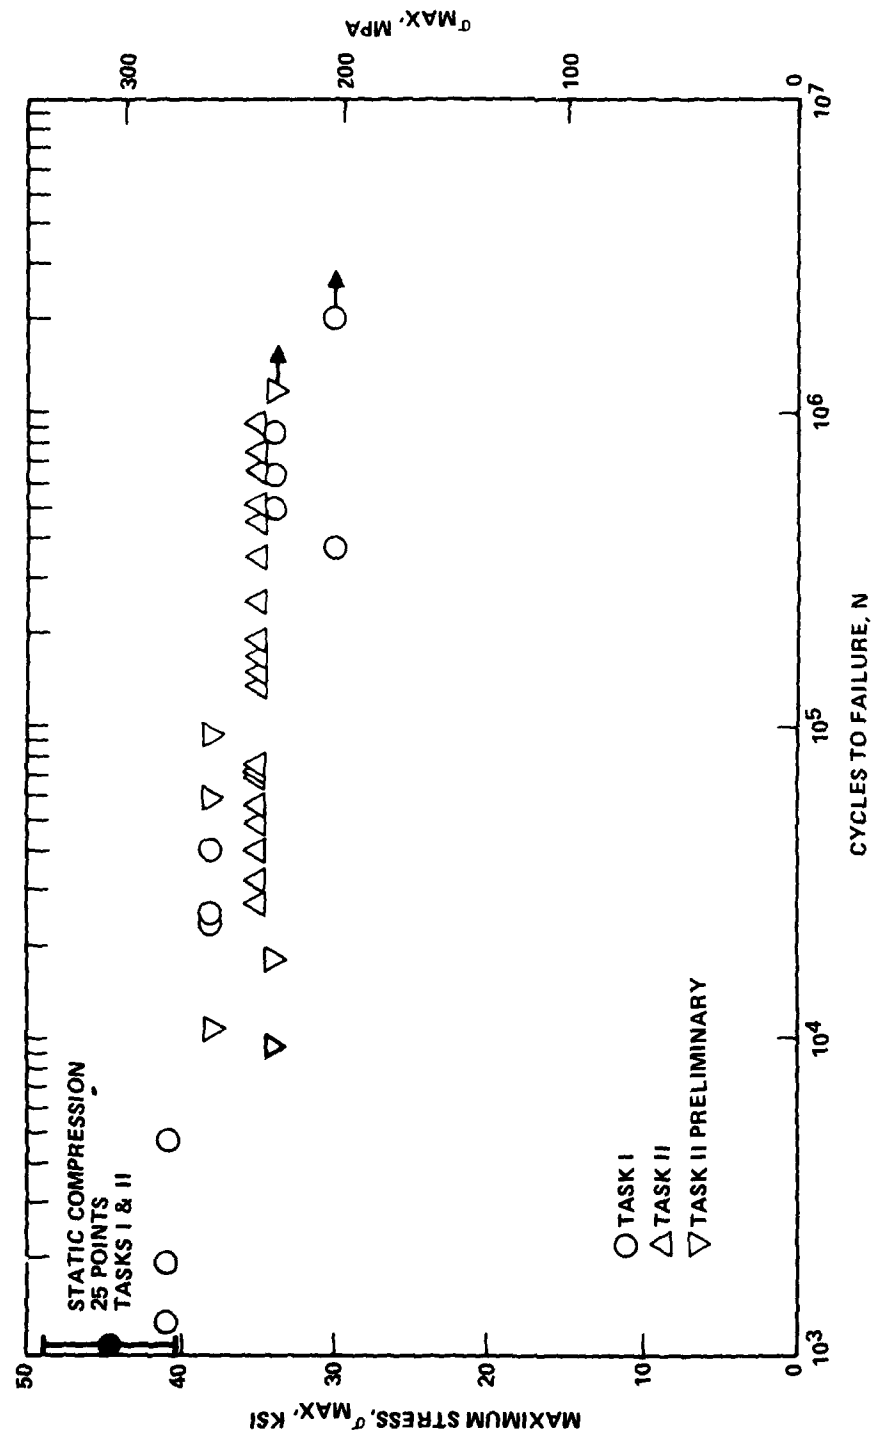
Figure 56 : Fatigue Scatter Results For 24-Ply Damaged Hole Specimens

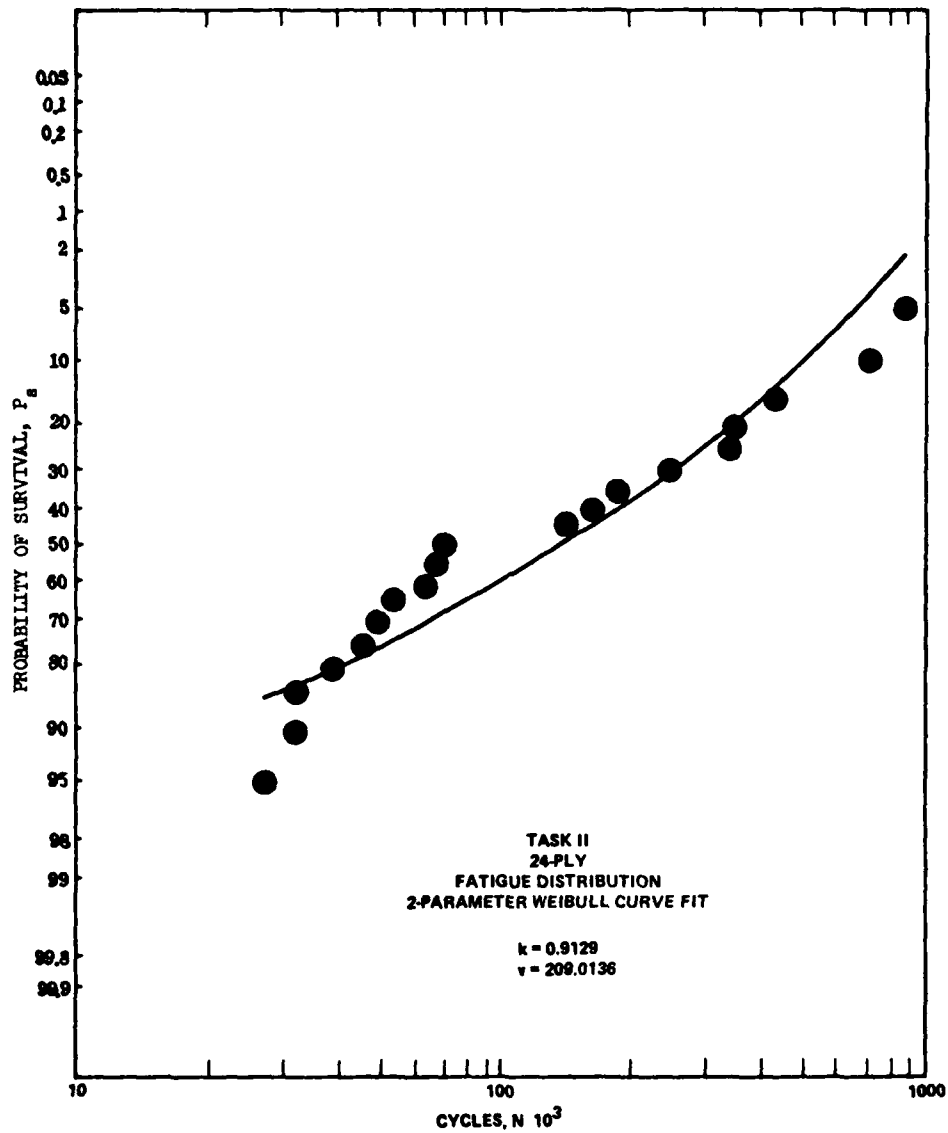
Figure 57: Two Parameter Weibull Curve Fit for Task II 24-Ply Fatigue Data, $\sigma_{Max} = 35$ ksi (241 MPa), $R = -1$

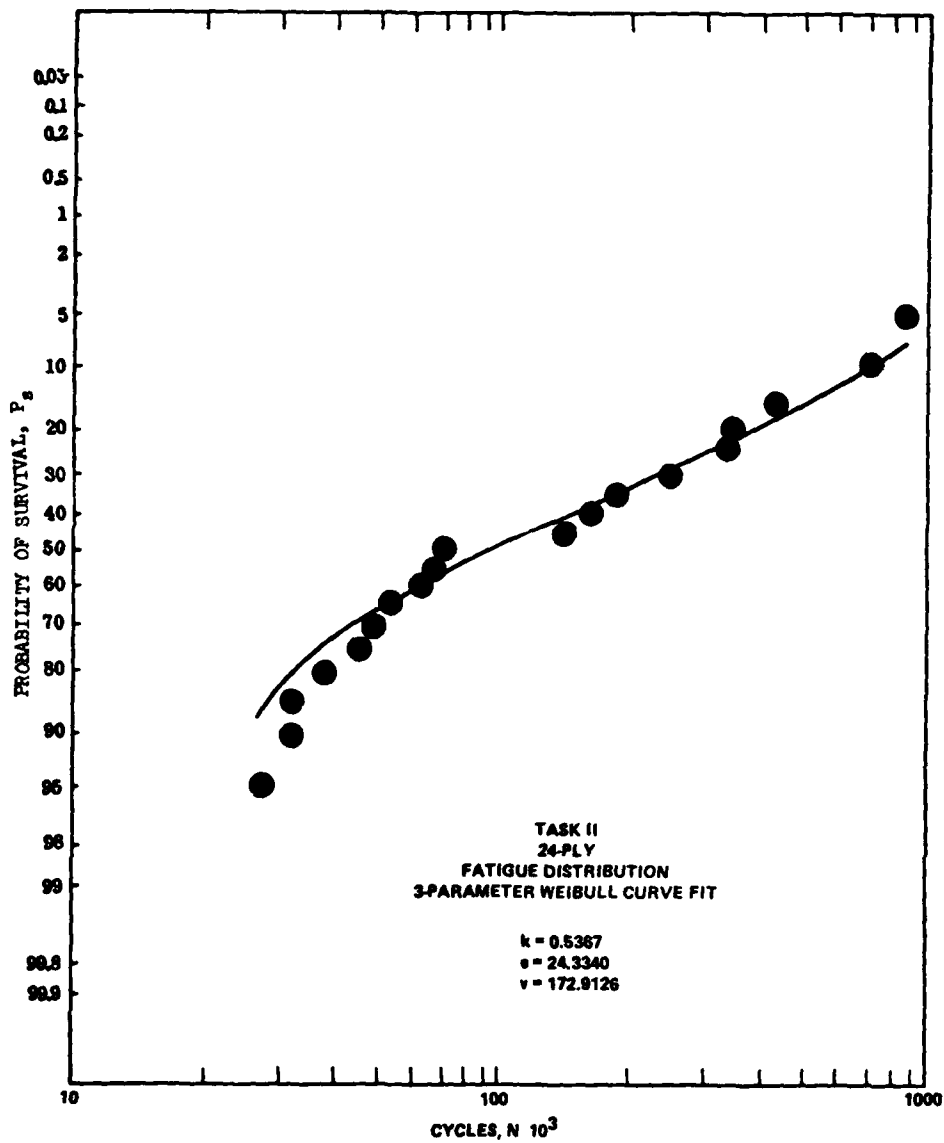
Figure 58: Three Parameter Weibull Curve Fit for Task II 24-Ply Fatigue Data, $\sigma_{Max} = 35$ ksi (241 MPa), $R = -1$

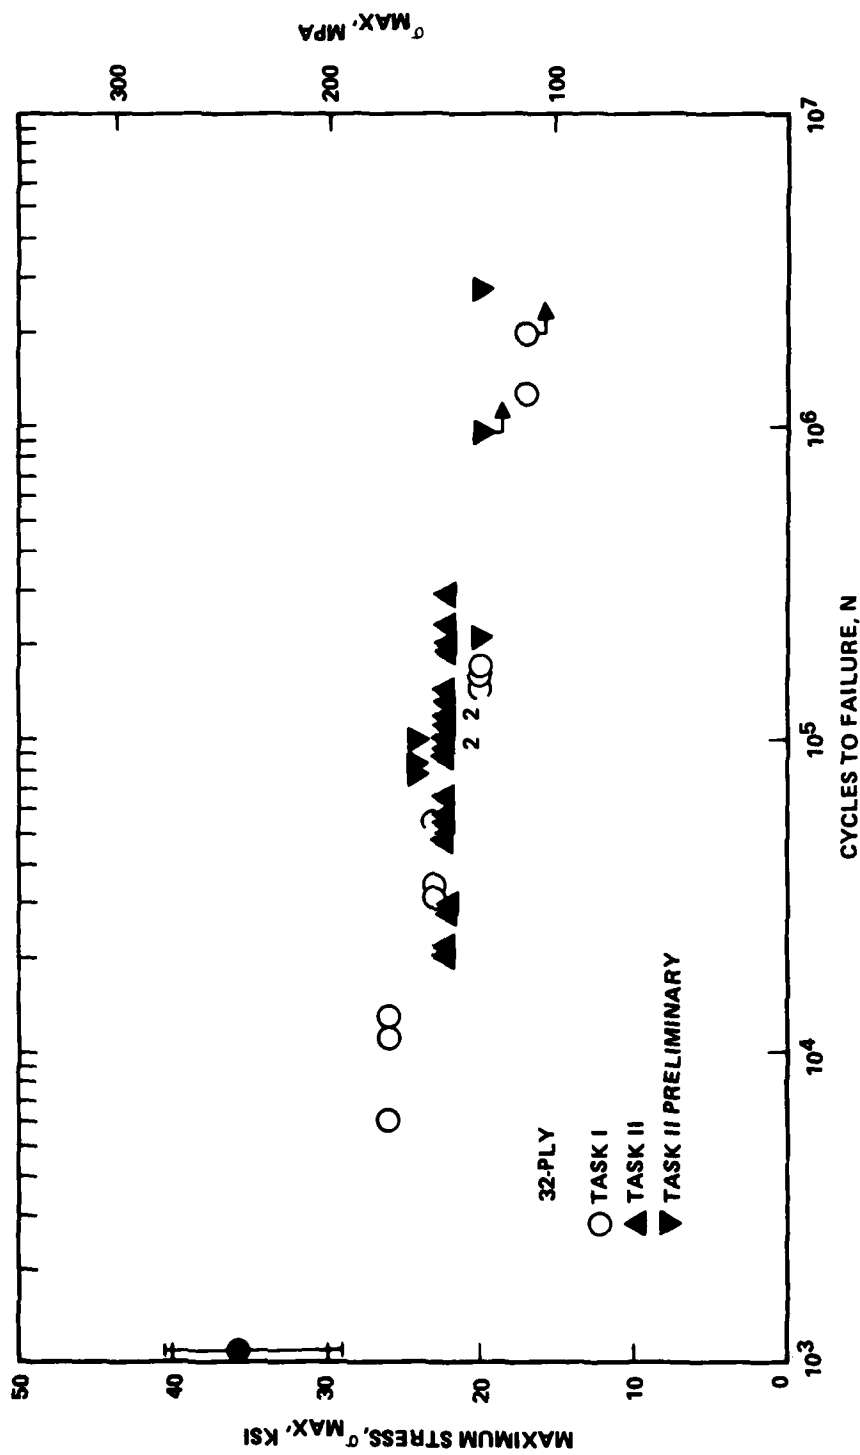
Figure 60: Fatigue Scatter Results for 32-Ply Damaged Hole Specimens
